## Emergency project saves water intake and supply

When the bank of Lake Sakakawea began to slide after heavy rains, there was limited time to respond. Those slopes hold the access road and pipelines for Fort Berthold Rural Water's intake, which serves the Mandaree water treatment plant and supplies raw water to the Bakken oil field.

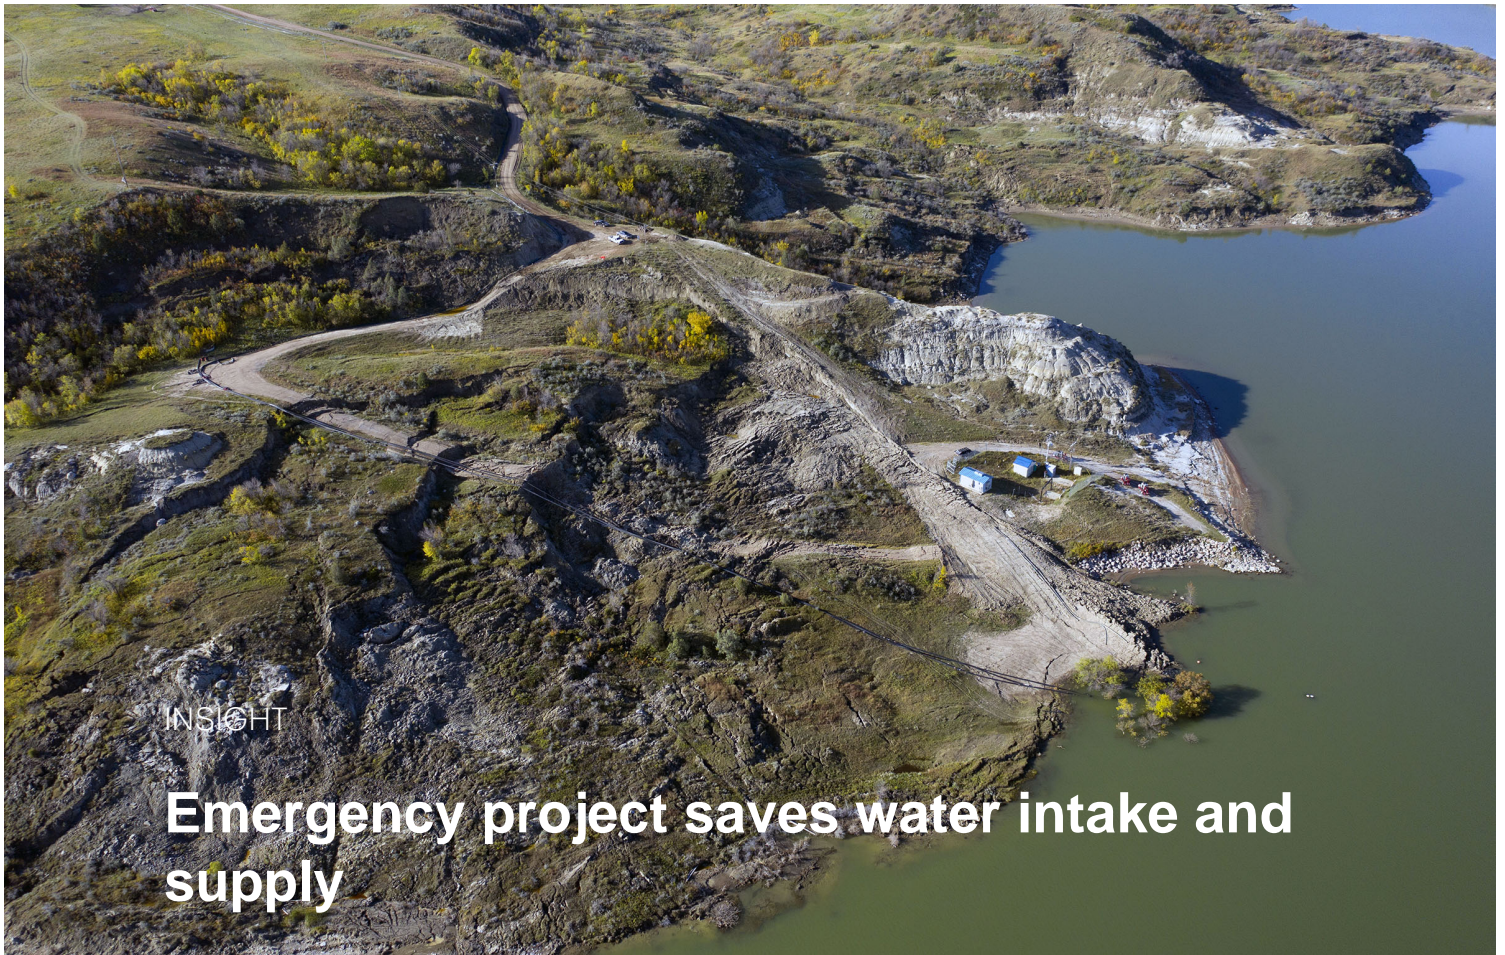
After a weekend of heavy rainfall in late September 2019, the bank of the intake began to slide. The landslide measured approximately 1,000 feet in width and length, covering a vertical elevation range of about 250 feet. As James Landenberger, a professional engineer at Bartlett & West, said, "I've been involved in civil engineering for 20 years and I've never seen a slide like this." Landenberger said the bank looked like lava flow as it slid away.

The access road to the site was also destroyed during the slide—moving approximately 50 feet down the bank. Workers had to use all-terrain vehicles to access the area while a contractor worked to create an emergency access road.

Ultimately, in just a few months after the slide, all repairs were completed. Two new raw water pipelines were installed at the site, with the other line abandoned. Those new lines were horizontally, directionally drilled rather than trenched to limit further effect on the already compromised site. The access road and intake were also repaired.

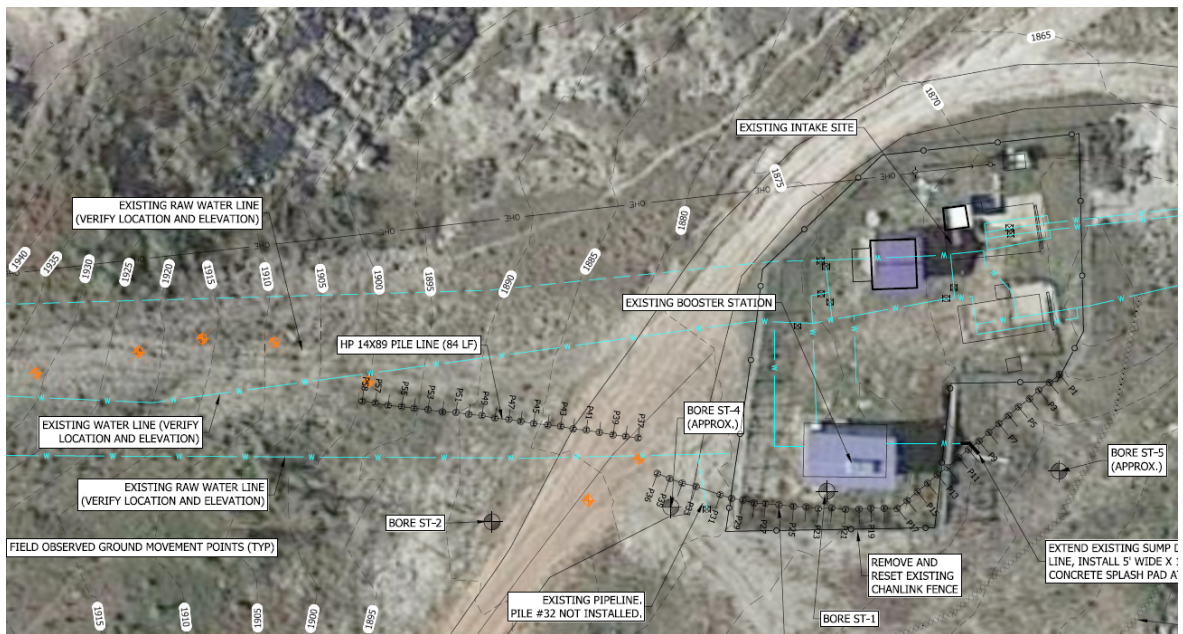
Figure 1. From Slide Area Pile Line Site Plan

Even prior to the slide, that intake site was already a cause for concern. In fact, in 2017, Bartlett & West and Braun Intertec worked together to protect key infrastructure and secure the intake after analysis showed that the hillside was compromised. At that time, movement of the landslide mass produced a pattern of ground cracks that suggested the intake's booster station, along with the water lines that extend south from the booster station toward Mandaree, could be at risk. Piles were drilled into the bank to help reinforce it, shown in Figure 1. Fast-forward to late 2019. Landenberger points out that the bank erosion all occurred directly below the line of the previously buried piles, with the pump station and bank located above and safely protected.

Landenberger said, "Drilling into an already unstable bank is not ideal. We were concerned that doing so might further contribute to the destabilization. However, those piles definitely saved the intake from being a complete loss when the slide occurred. They prevented a catastrophic failure."
