## Data and evidence show the way

*This article was originally published by [Water Environment Technology](#) in July 2021.*

*Authors: Michael F. Lorenzo, P.E., engineer at Bartlett & West and Michelle Neiswender, P.E., project manager at City of Topeka Utilities, Topeka, KS*

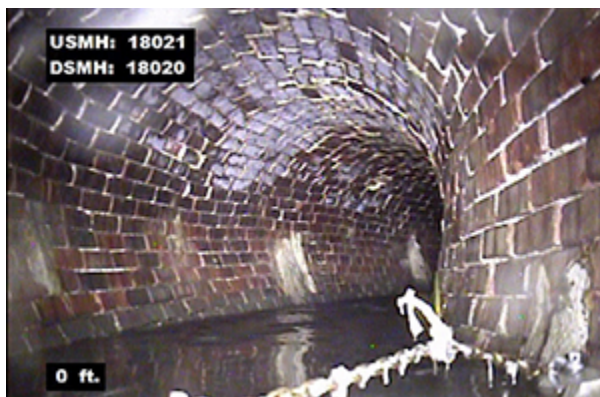
Brick storm sewer pipe

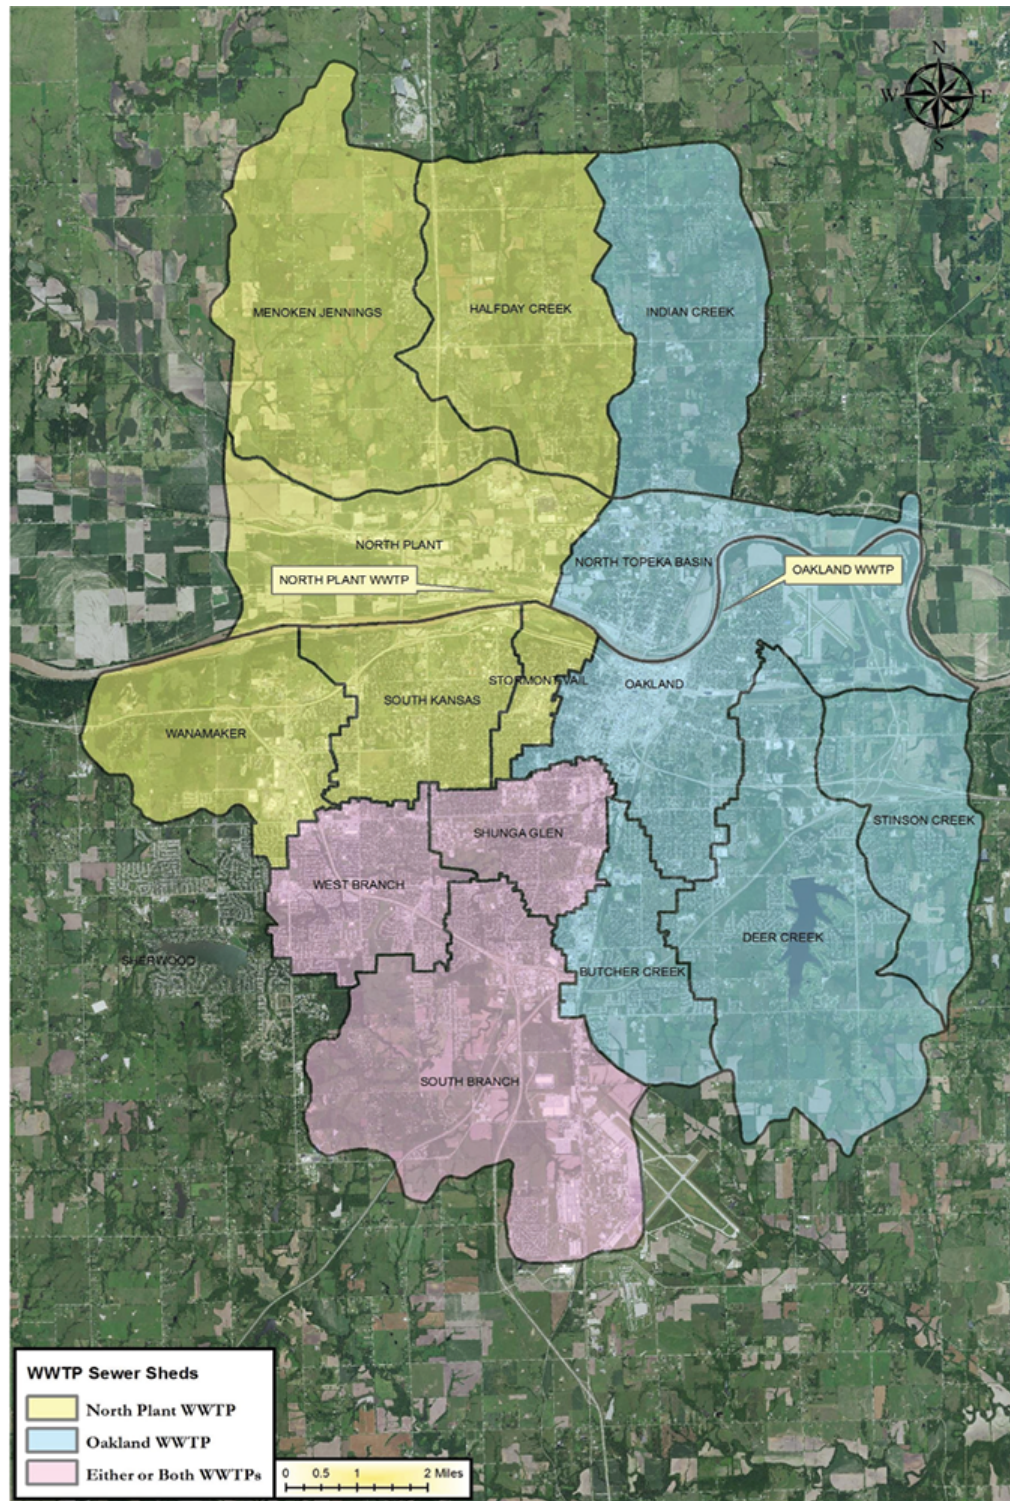
Figure 1. City of Topeka Sewer Sheds

The overall collection system consists of 15 wastewater basins as shown in Figure 1 (p. 35). The total area of all basins is approximately 383 km<sup>2</sup> (148 mi<sup>2</sup>). The two CSS basins, North Topeka, and Oakland, have an area of 46.6 km<sup>2</sup> (18 mi<sup>2</sup>). Two WRRFs provide treatment of flows collected by the system. The 1.05 m<sup>3</sup>/s (24 million gal/d) peak flow North Plant Wastewater Treatment Plant serves basins in the west and northwest while the 4.38 m<sup>3</sup>/s (100 million gal/d) peak flow Oakland Wastewater Treatment Plant serves basins in the south, central, and east.

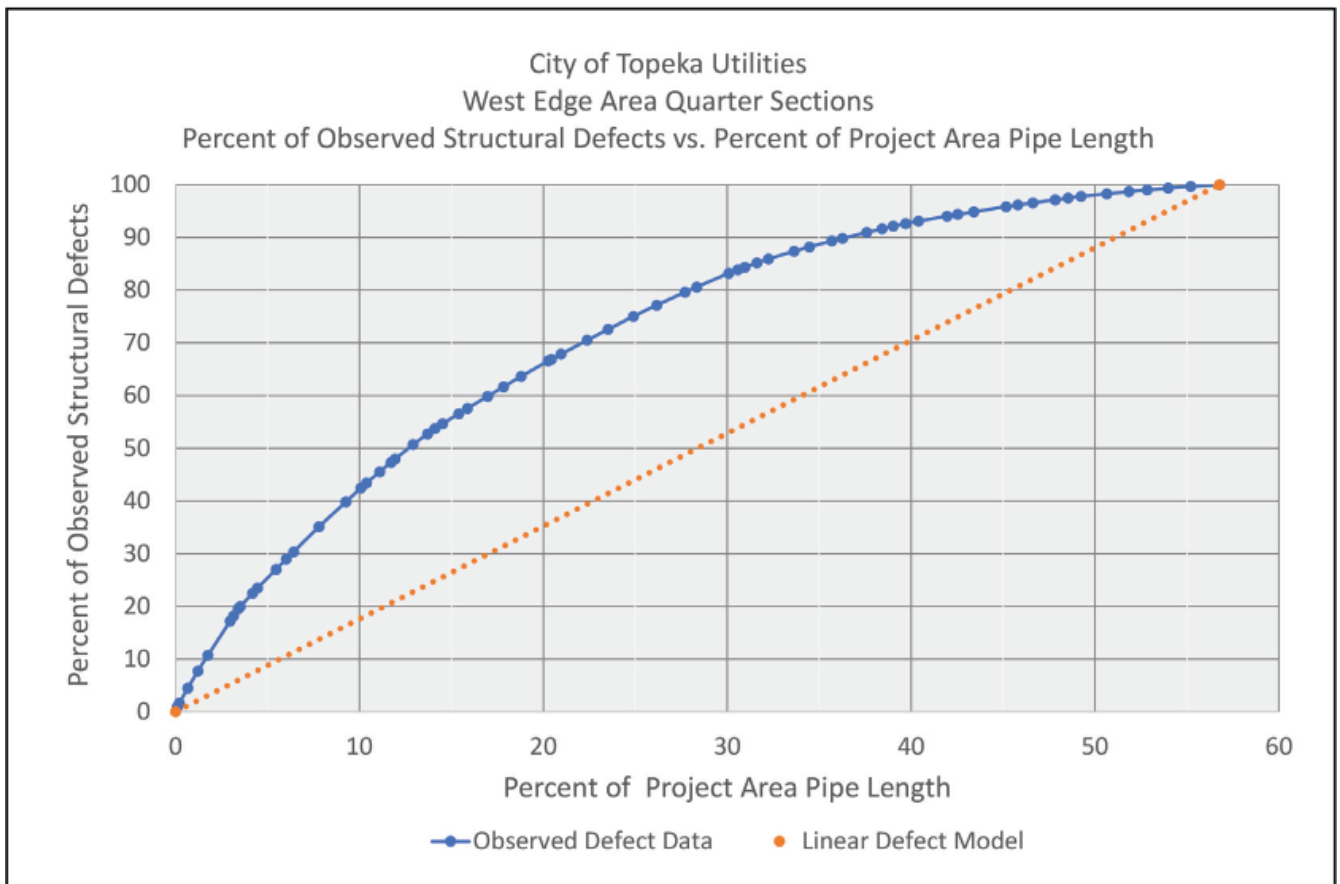
The use of a cost-effectiveness of 1.00 also was assessed through a knee-of-the-curve analysis in which percent of observed structural defects for each area was plotted against percent of project area pipe length. Figure 2 (p. 37) shows an example of this plot for the West Edge project area.

Figure 2 shows a comparison between the actual observed conditions, and the improvements that might be expected if structural defects were evenly distributed throughout the area pipes. The inflection point of the observed defect data is found to occur at approximately 26% of the project area pipe length and is associated with elimination of 46% of structural defects.

This correlates to a pipe in the West Edge area with a cost-effectiveness factor of about 2.95. Similar results are obtained for the other project areas. Therefore, the cost-effectiveness factor of 1.00 is conservative in that it is generally somewhat past the knee-of-the-curve. (The development of manhole improvement recommendations was performed similarly to pipes although a cost-effectiveness factor was not used.)

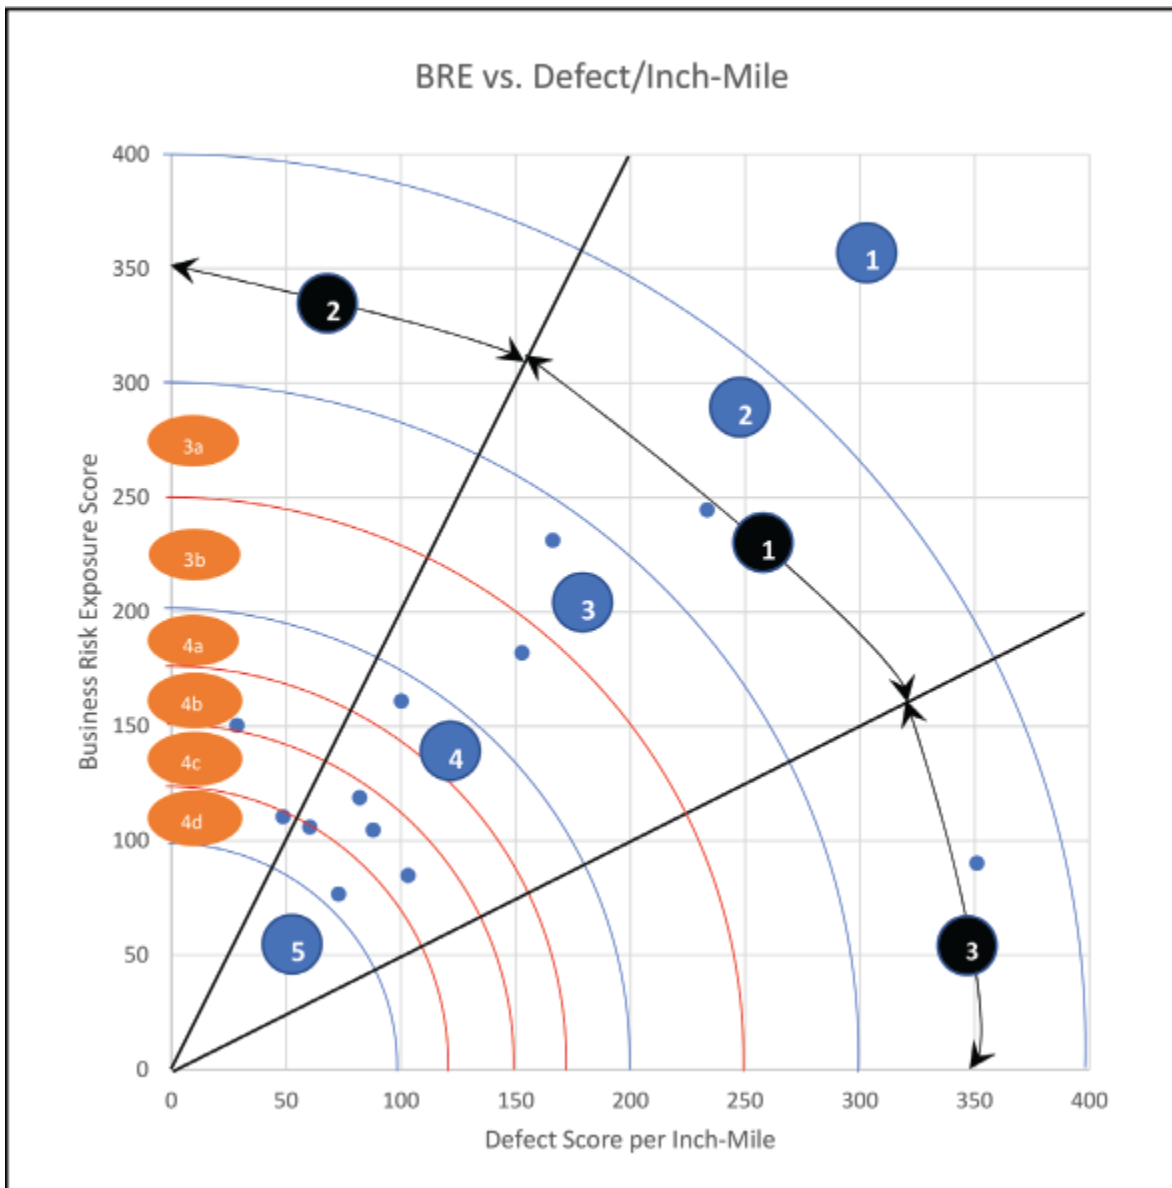
Table 3 (p. 38) summarizes the BREs, overall defect scores, and priority rankings of the 11 areas. The consolidated BRE and overall quarter section defect ratings for each quarter section are plotted on a graph to identify quarter sections with the highest overall risk in terms of consequences of failure (BRE) and likelihood of failure (overall defect rating). Figure 3 (below) presents BRE versus overall defect rating for 11 quarter section areas and the West Edge area project.

Figure 3 is divided into major risk zones, major risk zone sectors, and major risk subzones. The lower the number and number-letter combination, the higher the risk is considered. Therefore,

major risk zone 1 has the highest criticality; risk sub-zone 4a is more critical than risk sub-zone 4b; major risk zone 5 is the least critical. The risk zones were developed to enable a more balanced consideration of areas with high overall defect ratings and low BRE scores against areas with high BREs and lower overall defect ratings.
