## Data and evidence show the way

*Authors: Michael F. Lorenzo, P.E., engineer at Bartlett & West and Michelle Neiswender, P.E., project manager at City of Topeka Utilities, Topeka, KS*

In this article, we highlight the story of how the City of Topeka, Kansas, has embraced the principles of asset management. The city has harnessed immense amounts of data to serve as the foundation of a defensible, evidence based decision-making process to guide capital improvement planning for its wastewater collection system.

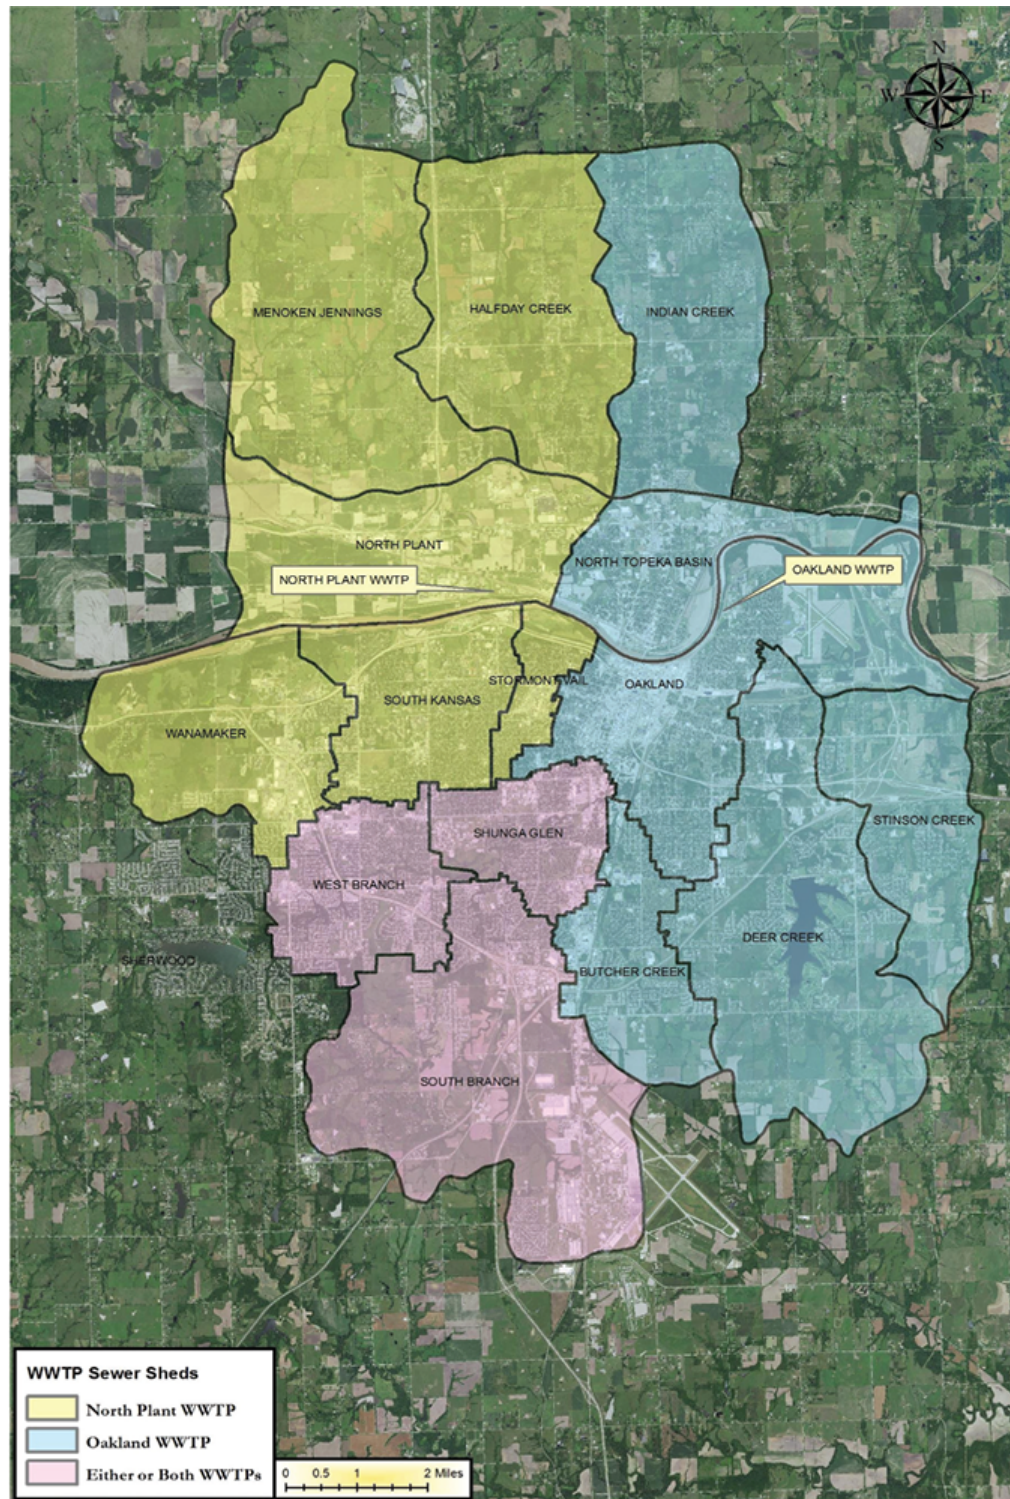
Figure 1. City of Topeka Sewer Sheds

The overall collection system consists of 15 wastewater basins as shown in Figure 1 (p. 35). The total area of all basins is approximately 383 km<sup>2</sup> (148 mi<sup>2</sup>). The two CSS basins, North Topeka, and Oakland, have an area of 46.6 km<sup>2</sup> (18 mi<sup>2</sup>). Two WRRFs provide treatment of flows collected by the system. The 1.05 m<sup>3</sup>/s (24 million gal/d) peak flow North Plant Wastewater Treatment Plant serves basins in the west and northwest while the 4.38 m<sup>3</sup>/s (100 million gal/d) peak flow Oakland Wastewater Treatment Plant serves basins in the south, central, and east.
